# WEIDMAN MILL POND DAM INSPECTION

Dam Identification No.: 820  
Hazard Potential: Significant  
Section 18, T. 15 N. – R. 5 W  
Nottawa Township, Isabella County, Michigan  
Coldwater River

Date of Inspection: December 13, 2022  
Date of Report: December 2022

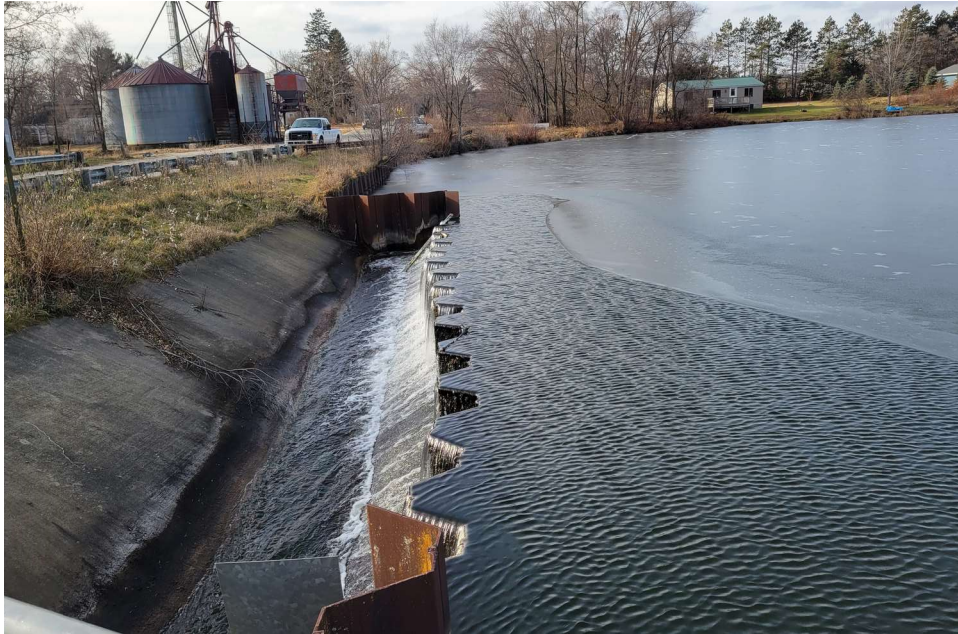
Weir Alignment Looking West

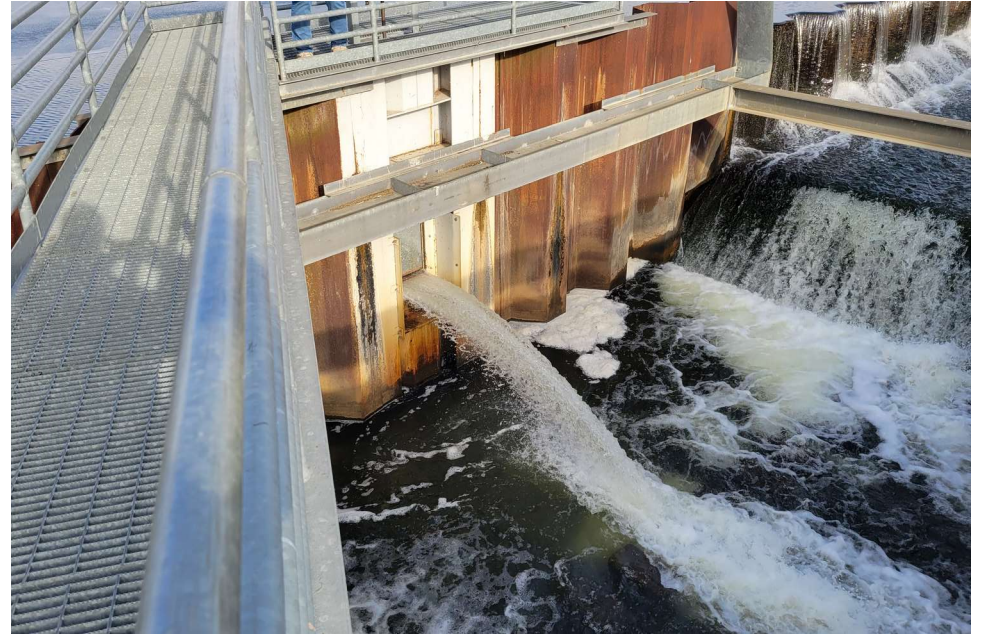
Sluice Gate Operational

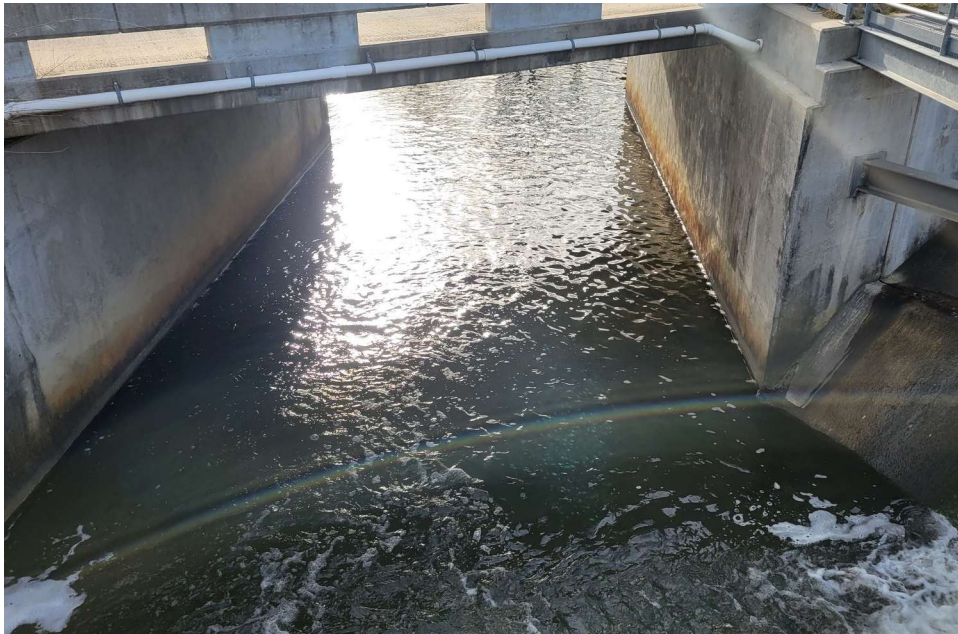
Concrete Condition through Outlet Channel

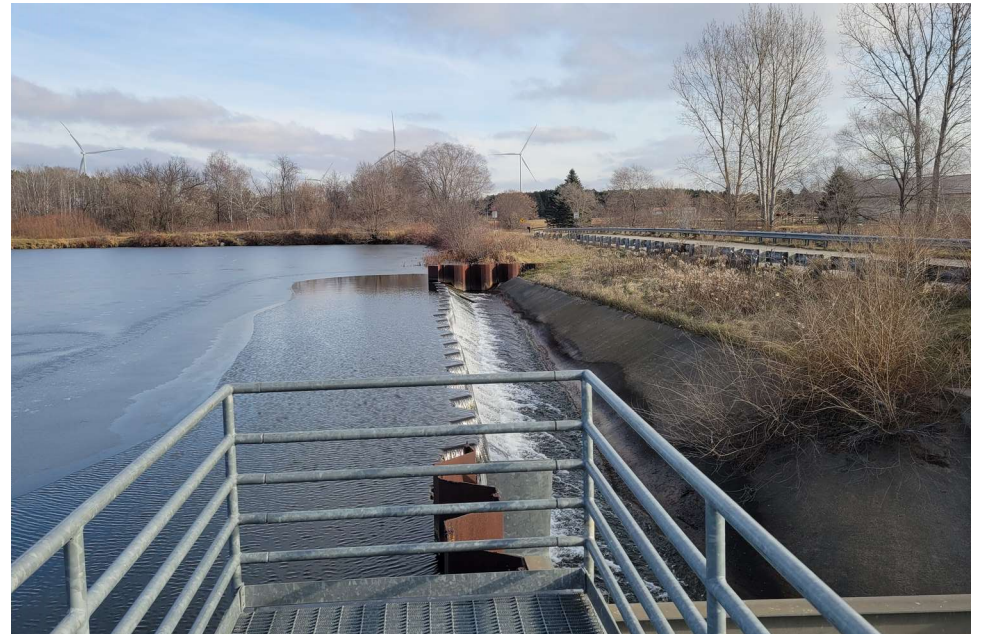
Weir Alignment Looking East

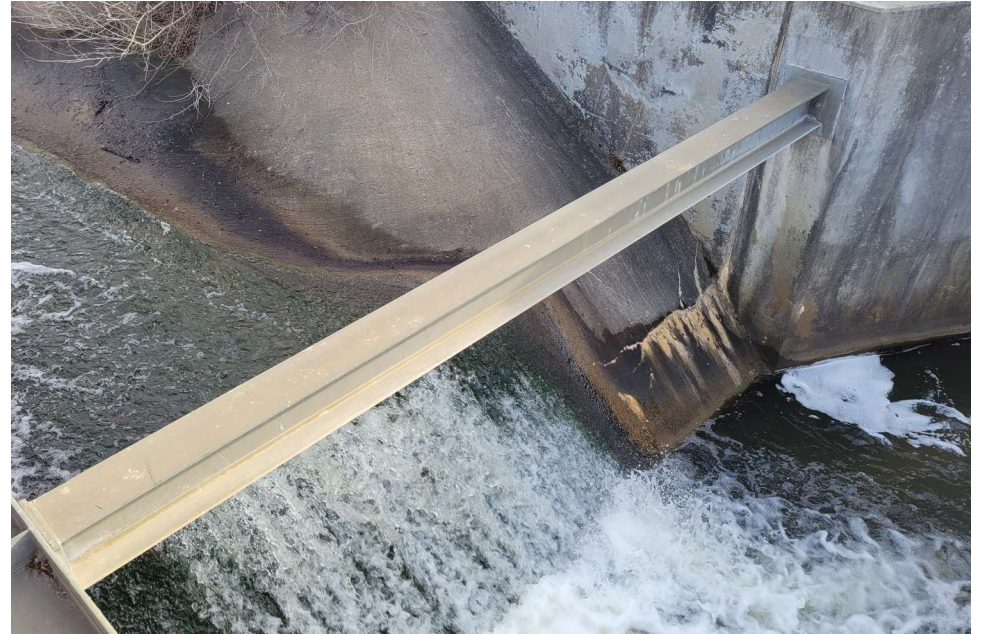
9. *Observation:* Multiple hairline cracks were observed on the back face of the right and left downstream concrete walls on the principal spillway with evidence of efflorescence.

Concrete Cracking and Efflorescence Along East Wall

*Recommendation:* Continue to monitor the cracks for change in size or separation.

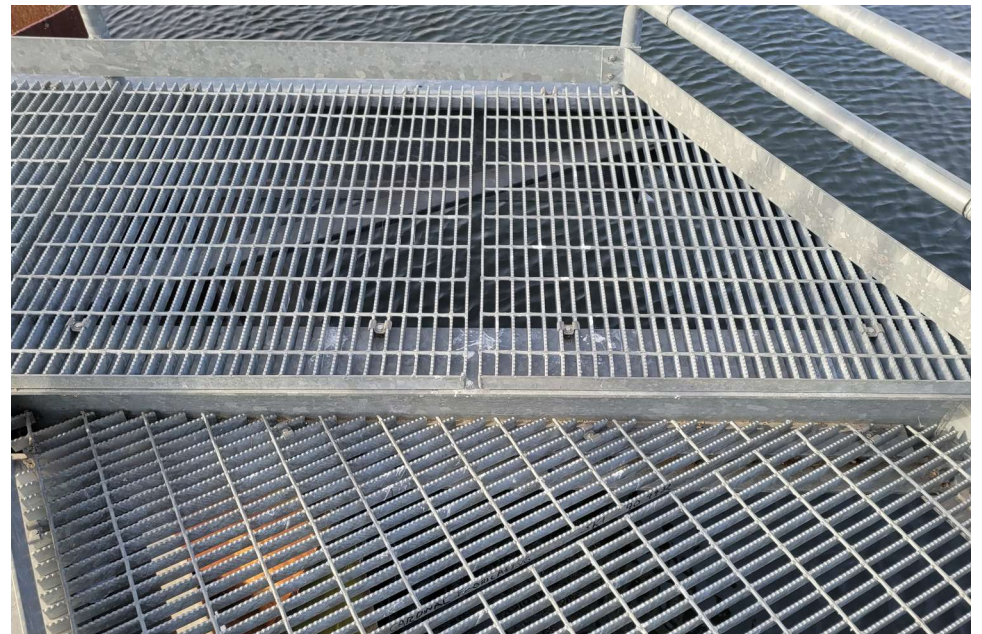
Catwalk and Railing in Good Condition

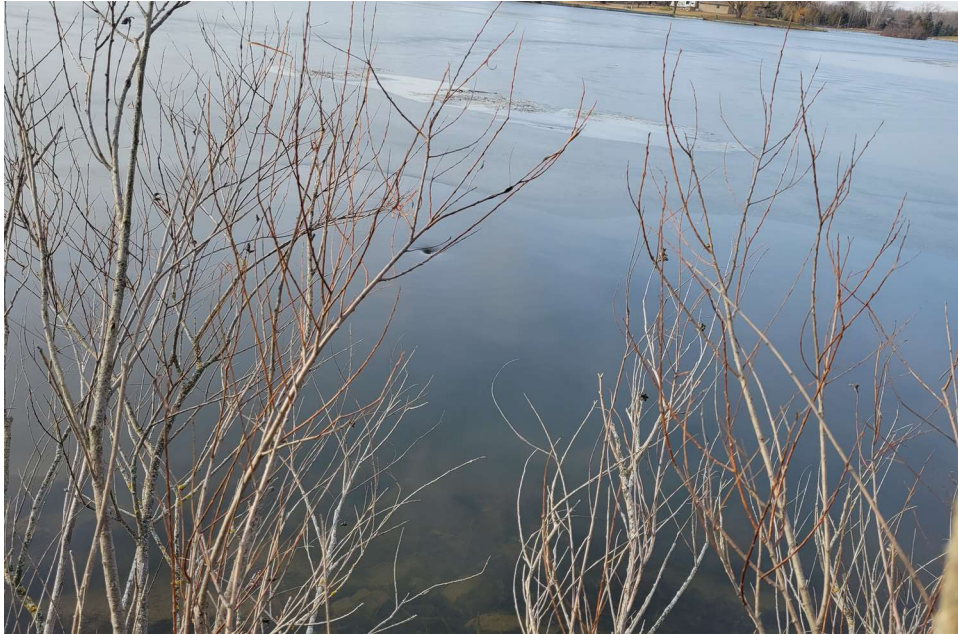
Vortex from Cold Water Discharge through Auxiliary Spillway

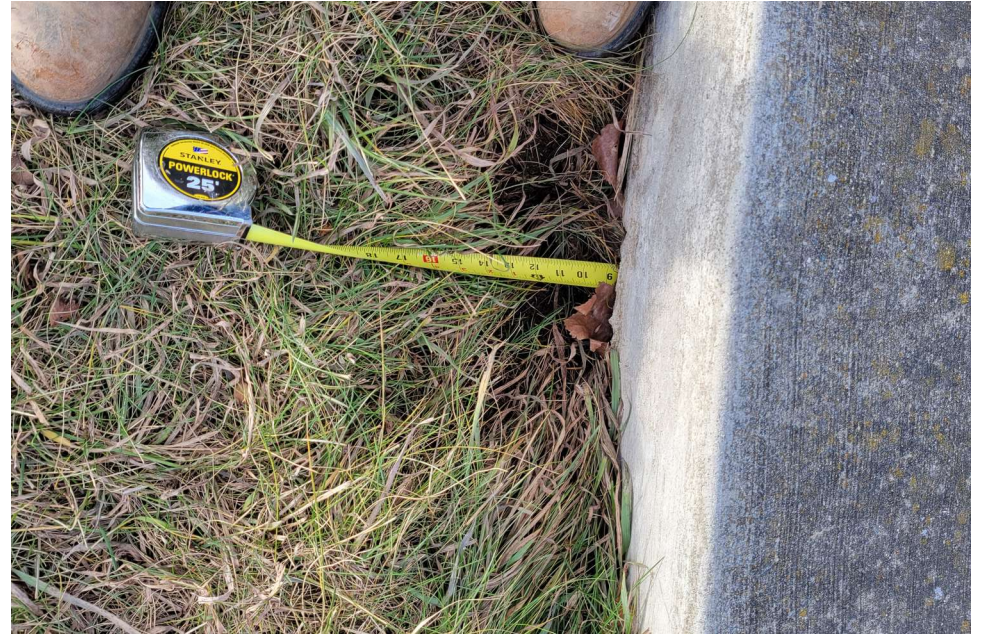
3. *Observation:* Void formed under concrete slab on eastern portion of the principal spillway.  
*Recommendation:* Pack void with backfill material and monitor to make sure void does not reform. If void persists further investigation would be needed to determine cause and a designed solution be implemented.

Void Underneath Slab on Eastern End of Structure

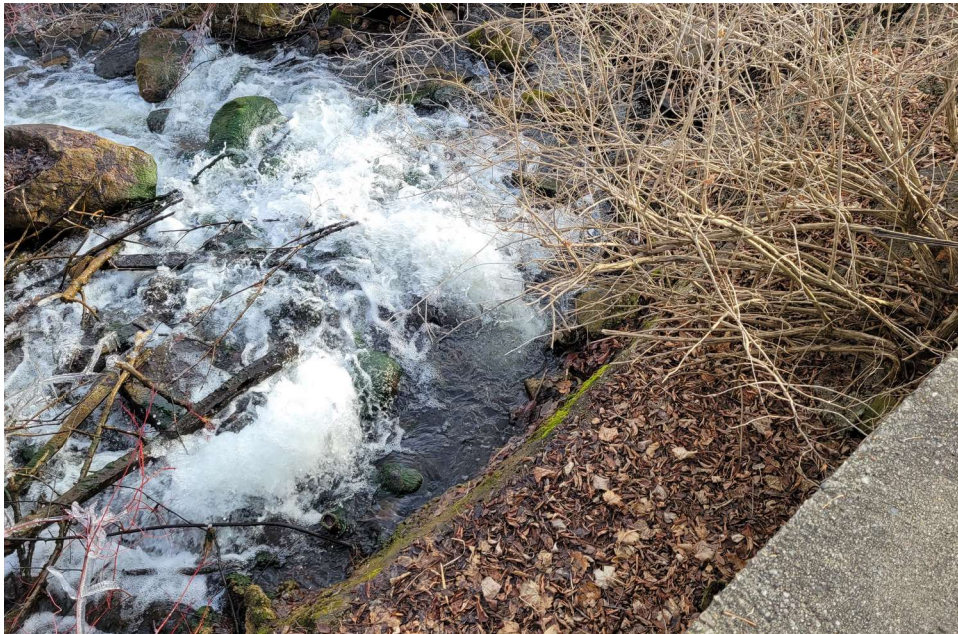
Cold Water Discharge Downstream of Auxiliary Spillway

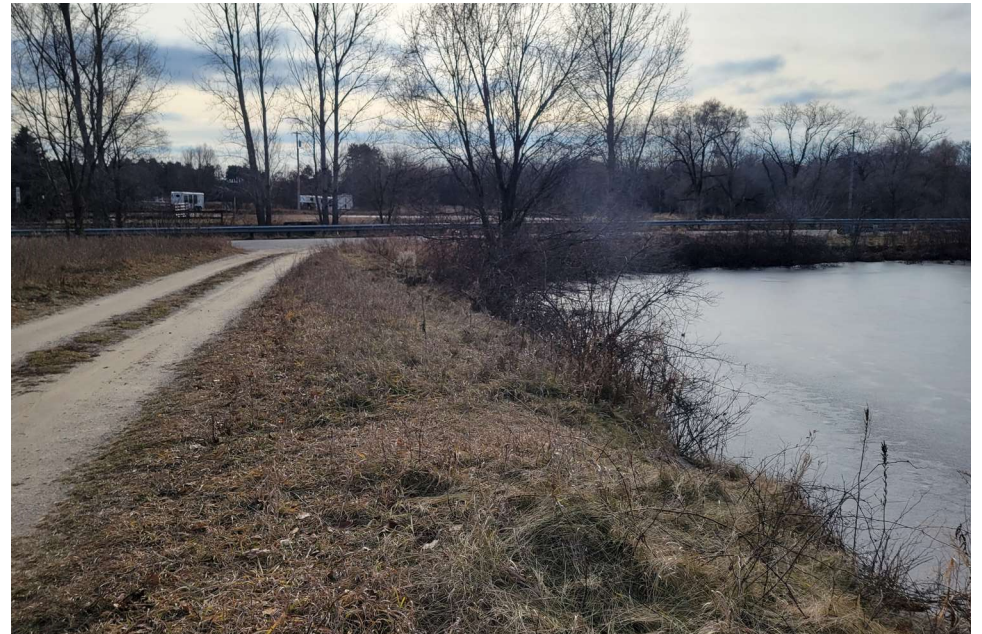
Looking South at Brush and Tree Growth Along Embankment

- Recommendation:* Remove all brush and trees from the downstream slope and spray cut stumps with a growth inhibiting herbicide. If the removal of trees and brush leaves the embankment void of vegetation, the embankment shall be seeded and mulched to promote grass growth. Also, if animal burrows are evident, rodents shall be removed, and the burrows filled. After the removal of brush and tree growth, the downstream slope should be monitored for signs of seepage.

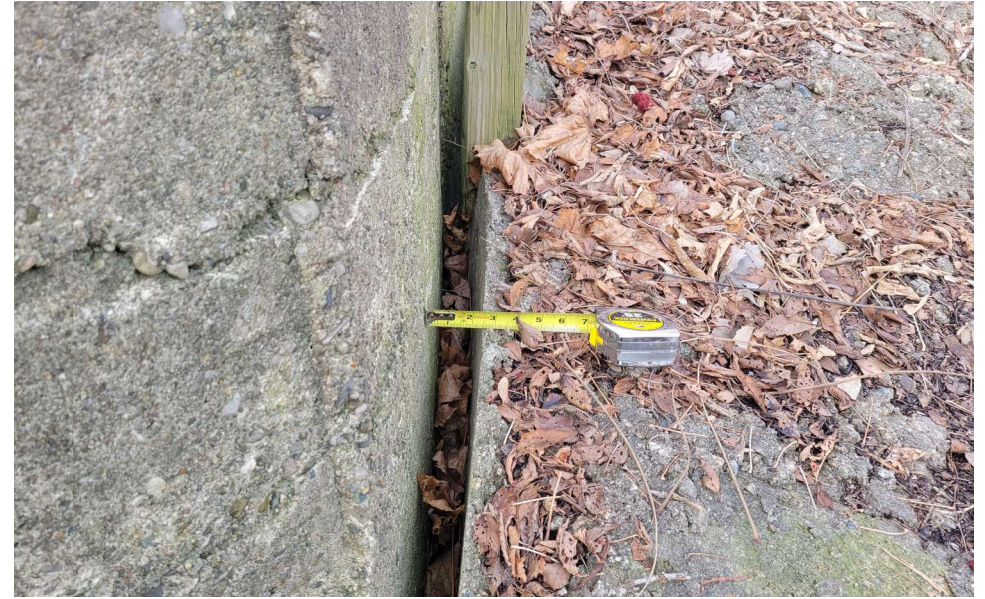
5. *Observation:* The overflow spillway located on the north/south embankment, north of Bridge Street, shows signs of separation and multiple cracks throughout.  
*Recommendation:* The separation at the concrete joints should be monitored for any potential movement. Crack monitoring devices can be installed for this purpose. At some point this spillway will have to be considered for replacement or significant rehabilitation.

Approx. 2.5" Gap between Downstream Headwall and Wingwall on Auxiliary Spillway

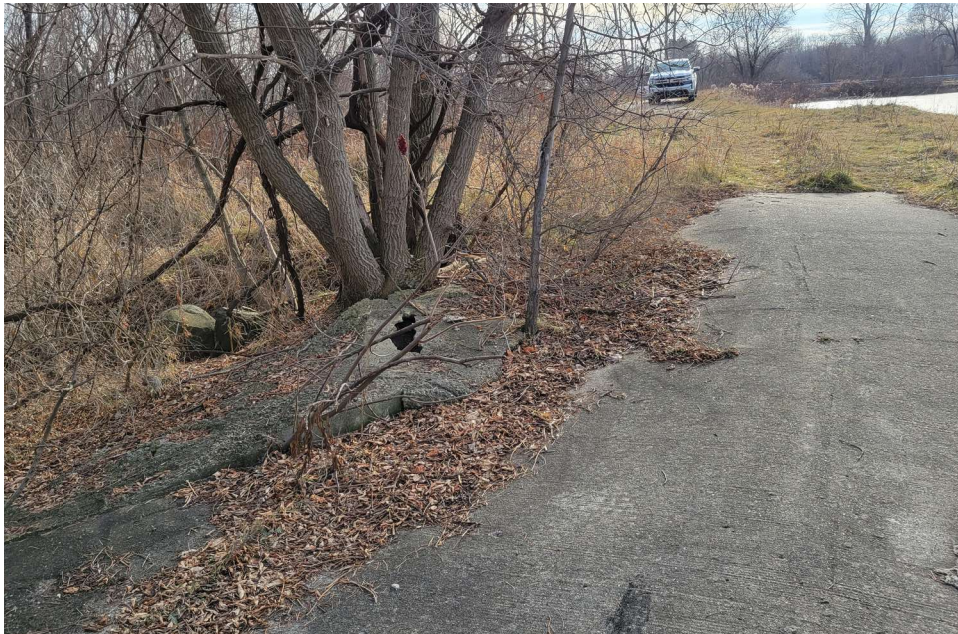
Tree Growing Next to Auxiliary Spillway

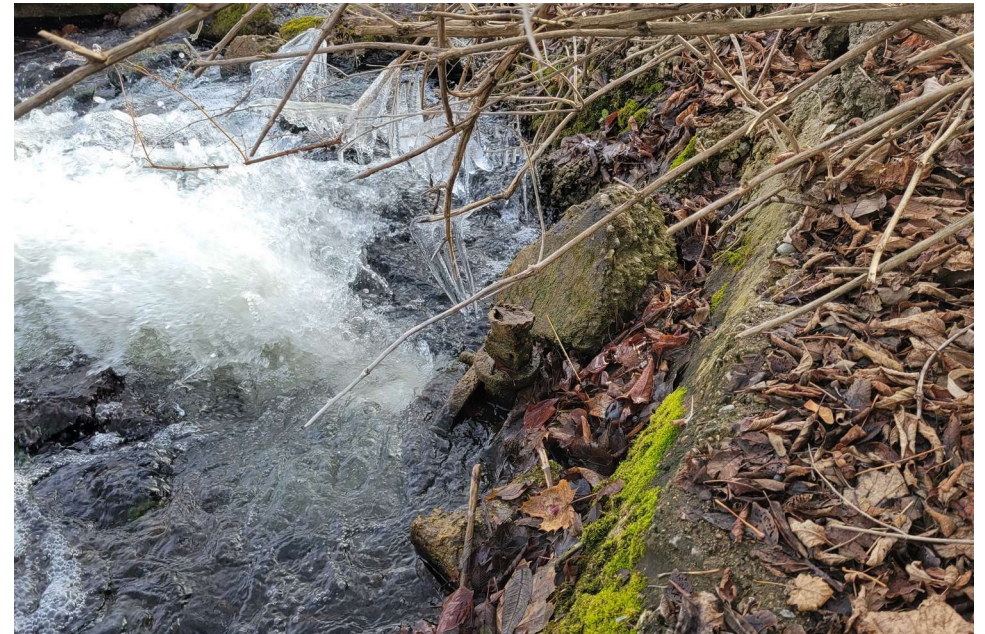
The secondary spillway consists of two cold water draw pipes with apparent valves on their lower end approximately 4-6 feet below the east embankment crest. The valves appear to be partially open and are likely inoperable. The size and type of the cold-water tubes was not determined at the time of the inspection. It appears there is several large pieces of broken concrete in front of the outlet pipes that are deflecting flow.

Cold Water Discharge Valve

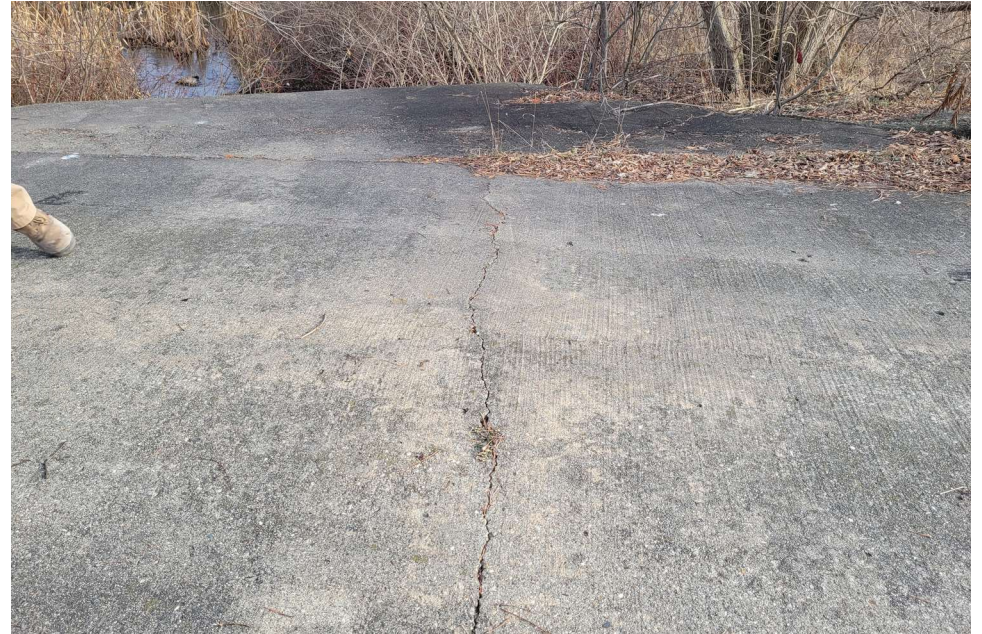
4. The concrete secondary spillway located north of Bridge St. was in poor condition. There were signs of cracking and separation between portions of the concrete. These joints should be monitored for any signs of movement. The spillway appears to have a cold-water discharge that outlets at the base of the spillway. A previous inspection report indicates that this outlet consists of 2 separately gated pipes. This could not be verified during the inspection because the inlet pipes are not visible when normal water levels are present. At this time, rocks appear to have been lodged at the outlet of the pipes causing the water to outlet in a vertical direction.

Concrete Cracking in Auxiliary Spillway

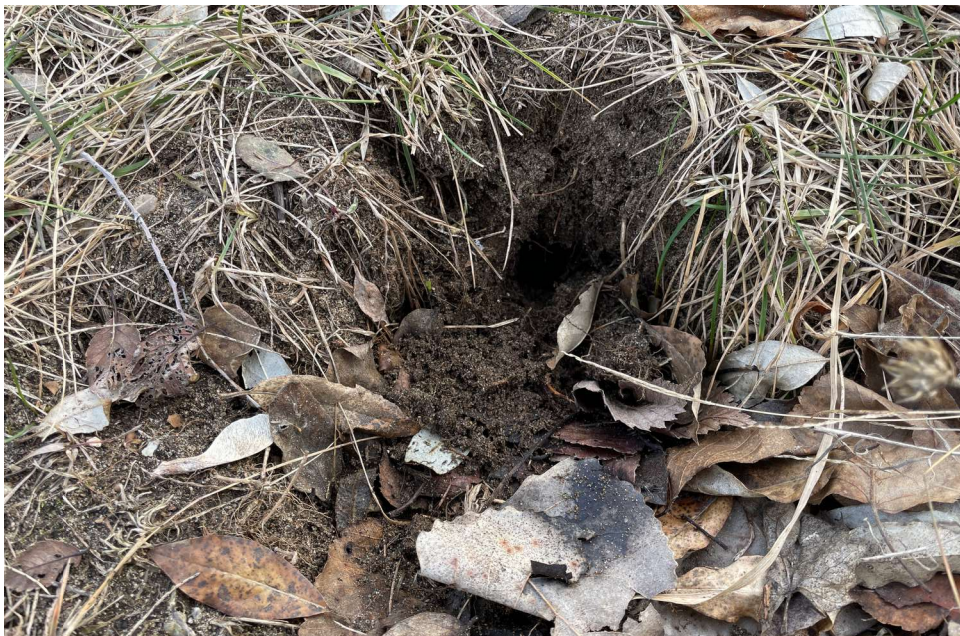
10. *Observation:* Animal burrowing or settling of soils were observed along the right downstream spillway trough of the primary spillway.

Rodent Hole in Embankment

*Recommendation:* Fill and compact Class II sand in void spaces and continue monitoring areas for disturbance.

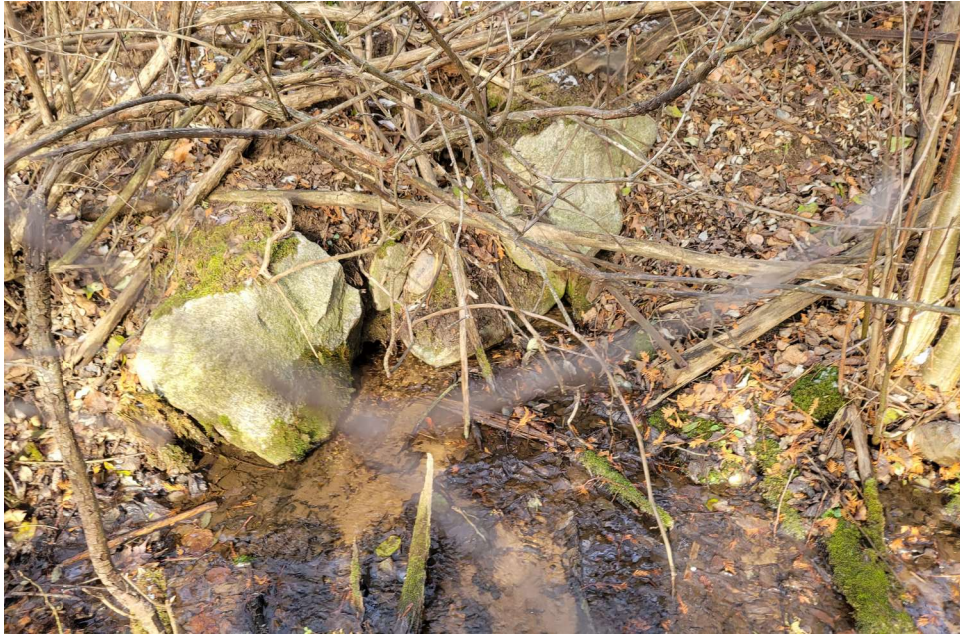
- Observation:* Significant seepage was observed along the downstream slope and at the downstream toe of slope for a portion of east embankment. At this time, transport of sand, sediment and flow through the impoundment was observed at Sta. 11+50.

Seepage through Embankment

*Recommendation:* Areas of seepage shall be repaired on the Weidman Dam Earthen embankment. Remove all brush and trees from the downstream slope to make monitoring and repair of the seepage areas easier.
- Observation:* Extensive brush and tree growth (up to 36" dia. ) exists along the upstream and downstream faces of the east embankment. Tree and brush growth on dam embankments has a number of negative impacts. Trees may be blown over by high winds resulting in the loss of embankment due to displacement of the root ball. The root structures of trees and brush may lead to piping of internal embankment materials from seepage through the dam and promote burrowing animals. Animal burrows may lead to further piping problems. The presence of brush and trees makes inspection of the dam difficult.

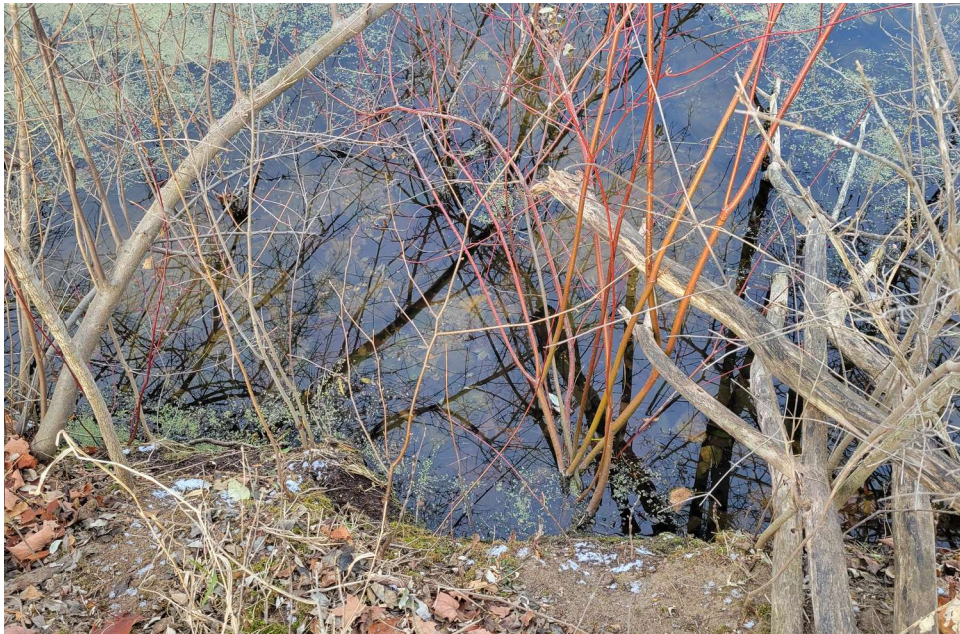
Upstream Side of Seepage Location

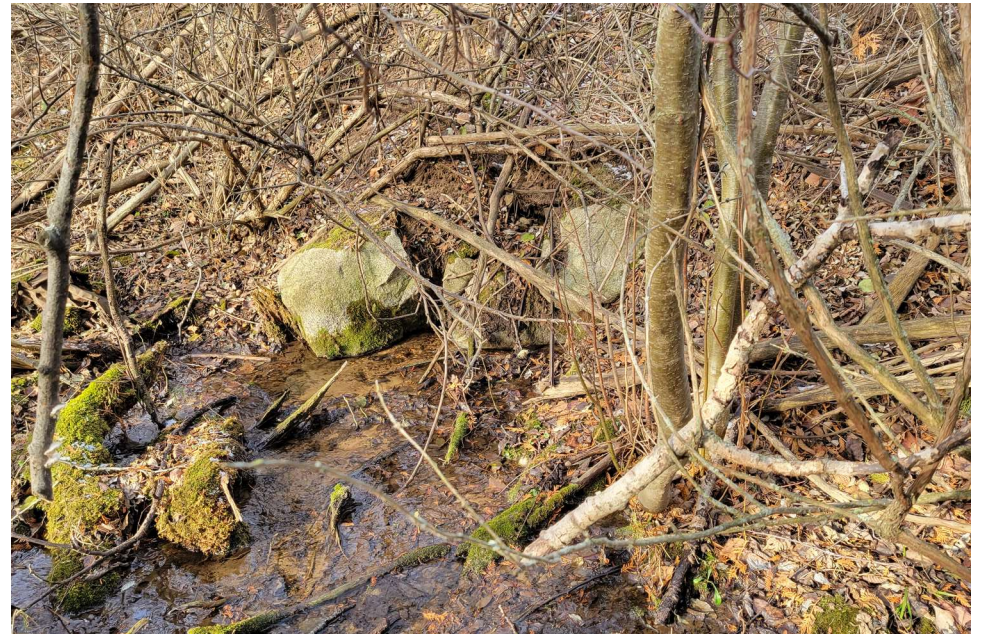
Seepage through Embankment at Eastern End of Embankment
